Workplace Health and Safety Bulletin

Worker Seriously Injured Servicing a Plunger Lift System

Incident description

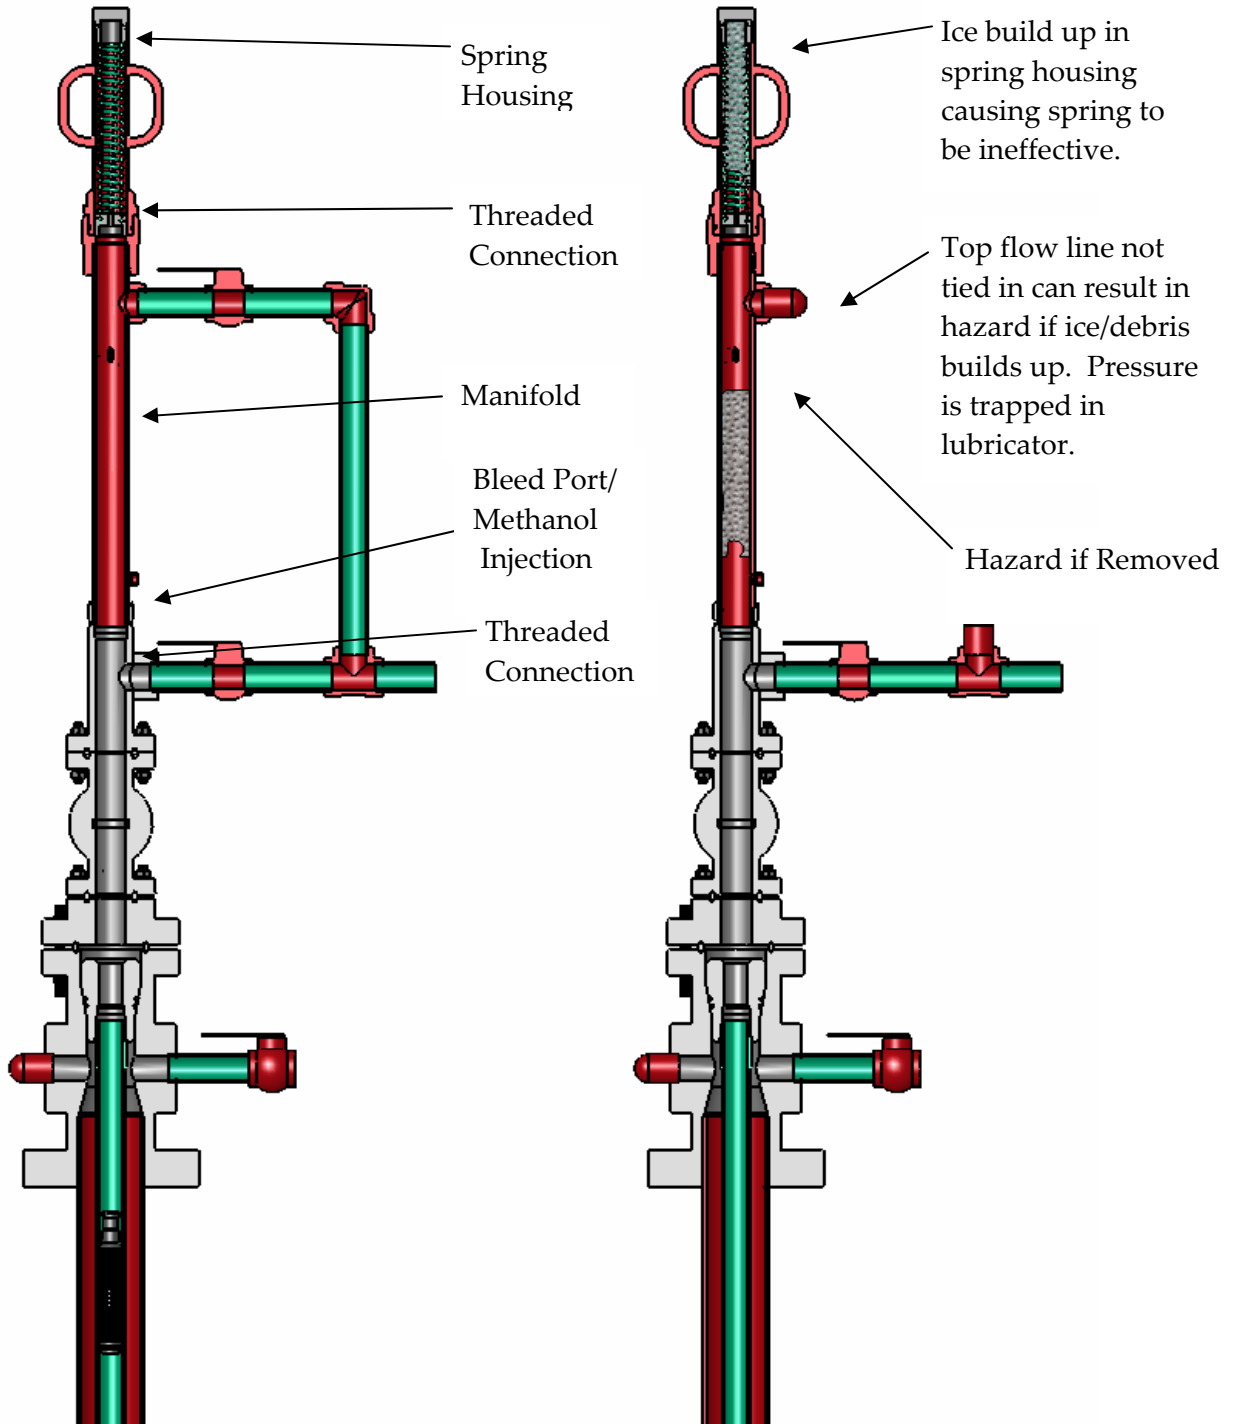
a) Typical Plunger Lift Installation b) Hazards from Not Tying in the top flow line

A service technician was seriously injured while servicing a plunger lift system. This recent incident occurred when an unsuspecting ice plug in the wellhead lubricator released and struck the worker in the head resulting in a fractured skull and permanent eye loss.

- Ice build up in the lubricator assembly.
- The ice build up in the lubricator was caused by produced water freezing in the assembly and no method of thawing the wellhead was available at this particular work site.
- Poor procedures in identifying potential hazards.
- Lack of operator training in safe work practices for the use of this equipment.
- No record of previous occurrences is available in the industry to track trends of incidents.
- No standard installation and servicing requirements are available to the industry.

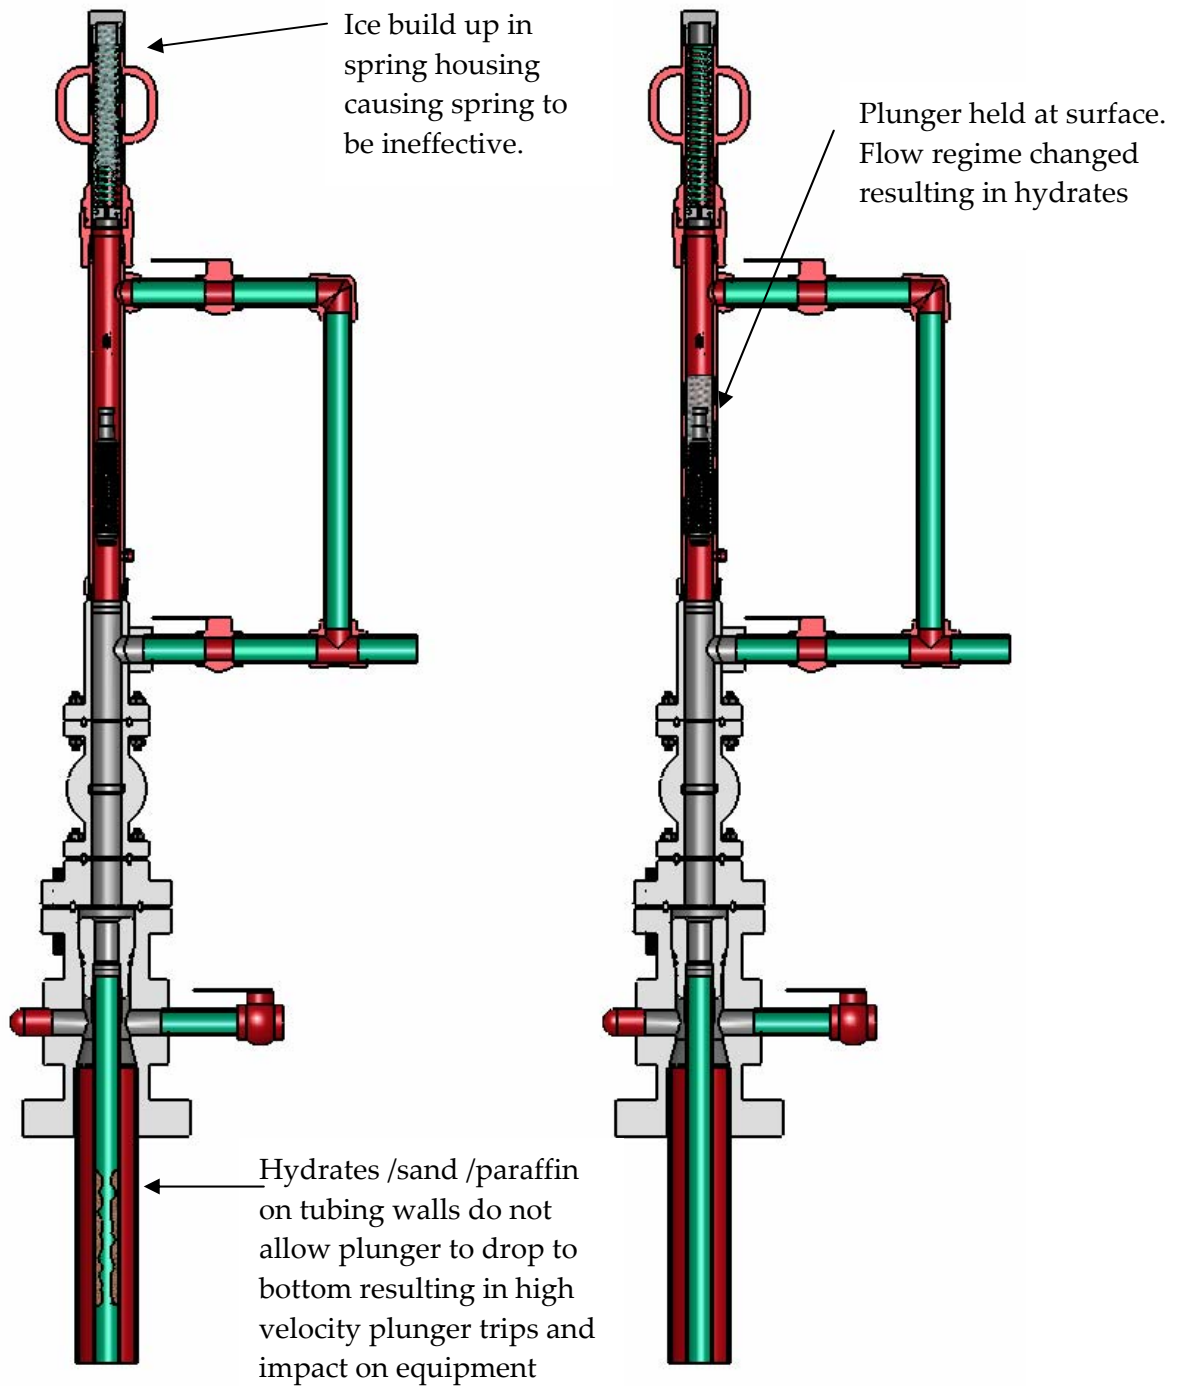
c) Hazards Associated with Impact Velocity d) Hydrate Potential with Plunger Lift

- Removing lubricator components with pressure contained above or below ice plugs, sand bridges etc.
- Ice build up in the spring housing causing impact forces of the plunger to be transferred to the lubricator housing and well head threads resulting in catastrophic equipment failure

- Paraffin, wax, sand and hydrates build up in the tubing string which will not allow the plunger to drop to the bottom of the well resulting in shorter, faster plunger arrivals at surface and impacting the lubricator assembly with greater force than normal

- Changes in line pressures resulting in faster higher velocity plunger arrivals
- Changes in the plunger configuration - as the well declines different plungers of various weights and lengths may be used to aid in production optimization and the travel velocity will also change

- No methanol injection or heat trace to keep ice and hydrates from forming in the lubricator assembly
- Restricted flow path if the plunger is being held at surface causing a pressure drop and creating the environment for the formation of hydrates

- Equipment should be of a design and function to withstand operating conditions with built-in safety factors.
 - Equipment should be impact rated as well as pressure rated-API 6A specifications for wellheads cover tensile and pressure but the potential for impact forces caused by malfunctioning plungers is not covered or discussed.

- Electronic control boxes should be set to record high velocity plunger times and to shut down after one or more high velocity arrivals.
 - Operators need to be trained to recognize why plungers are traveling at higher speeds and impacting with greater force and the potential consequences of repeated impacts on surface equipment.

- Installation and servicing procedures including risk and hazard control should be standard with all plunger installs.
 - Methods of controlling hydrate, ice build up should be considered when installing plungers on gas wells especially during winter months.
